UPDATED RESOURCE CONSERVATION AND RECOVERY ACT (RCRA)  
CONTINGENCY PLAN IMPLEMENTATION REPORT (CPIR) NO. 93-008 - TGH-552-93

RCRA CONTINGENCY PLAN  
IMPLEMENTATION REPORT NO. 93-008  
ROCKY FLATS PLANT  
EPA ID NUMBER CO7890010526

RESOURCE CONSERVATION AND RECOVERY ACT (RCRA) CONTINGENCY PLAN  
IMPLEMENTATION REPORT (CPIR) NO. 93-008

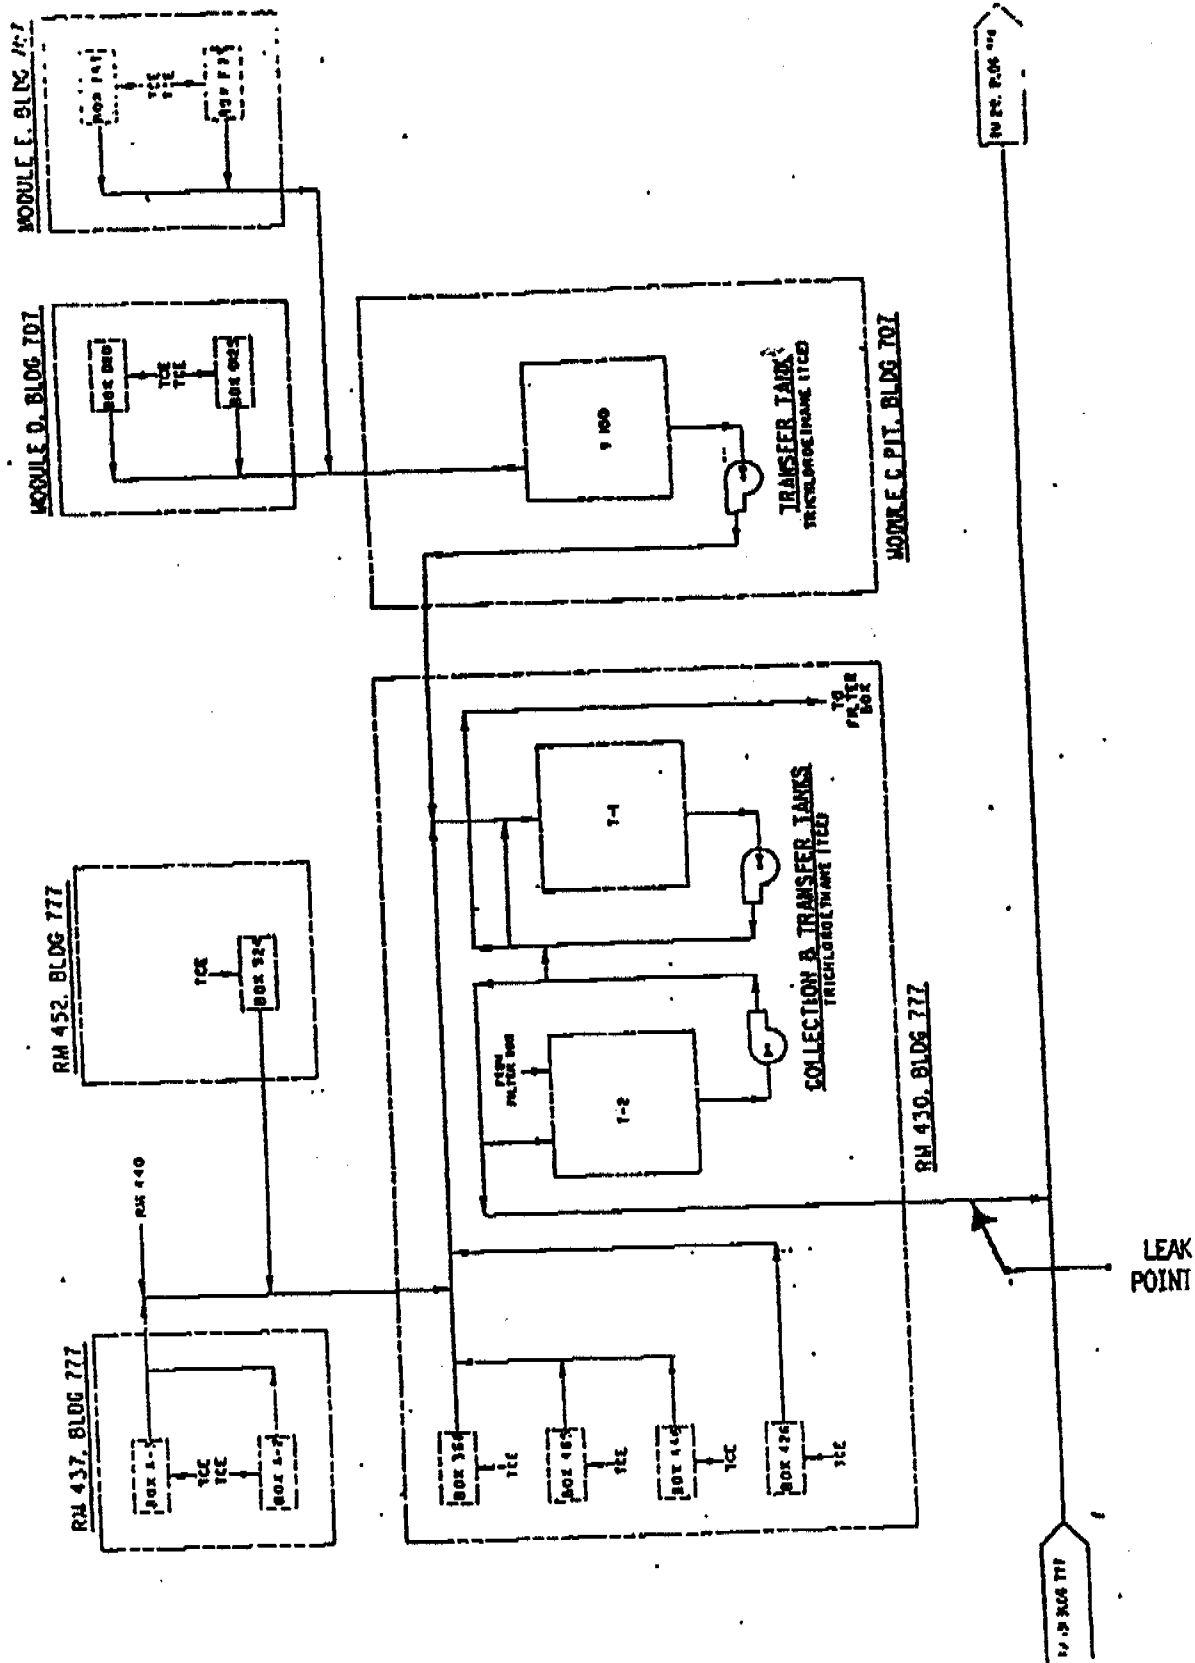
FIGURE 1  
PROCESS FLOW DIAGRAM  
WASTE TCA TANK SYSTEM

The first leak originated from a waste 1,1,1-trichloroethane (TCA) transfer line associated with tanks T-1 and T-2 (receiving and shipping tanks, respectively). These tanks were used to collect and transfer waste solutions containing TCA used in degreasing operations located in gloveboxes in various rooms in Building 777. In addition, spent TCA waste collected in tank V-100 in Building 707, Module C (pit) is transferred to tank T-1 (the receiving tank). The T-1 and T-2 tanks are located in the north central area of Room 430 in Building 777. Both tanks are filled with rashig rings to prevent a criticality. The solution collected in Tank T-1 is filtered in Glovebox No. FL-1, located next to the tanks, and then collected and sampled in Tank T-2 before the waste is transferred to Building 774 for treatment. A process flow diagram of this system is shown in Figure 1.

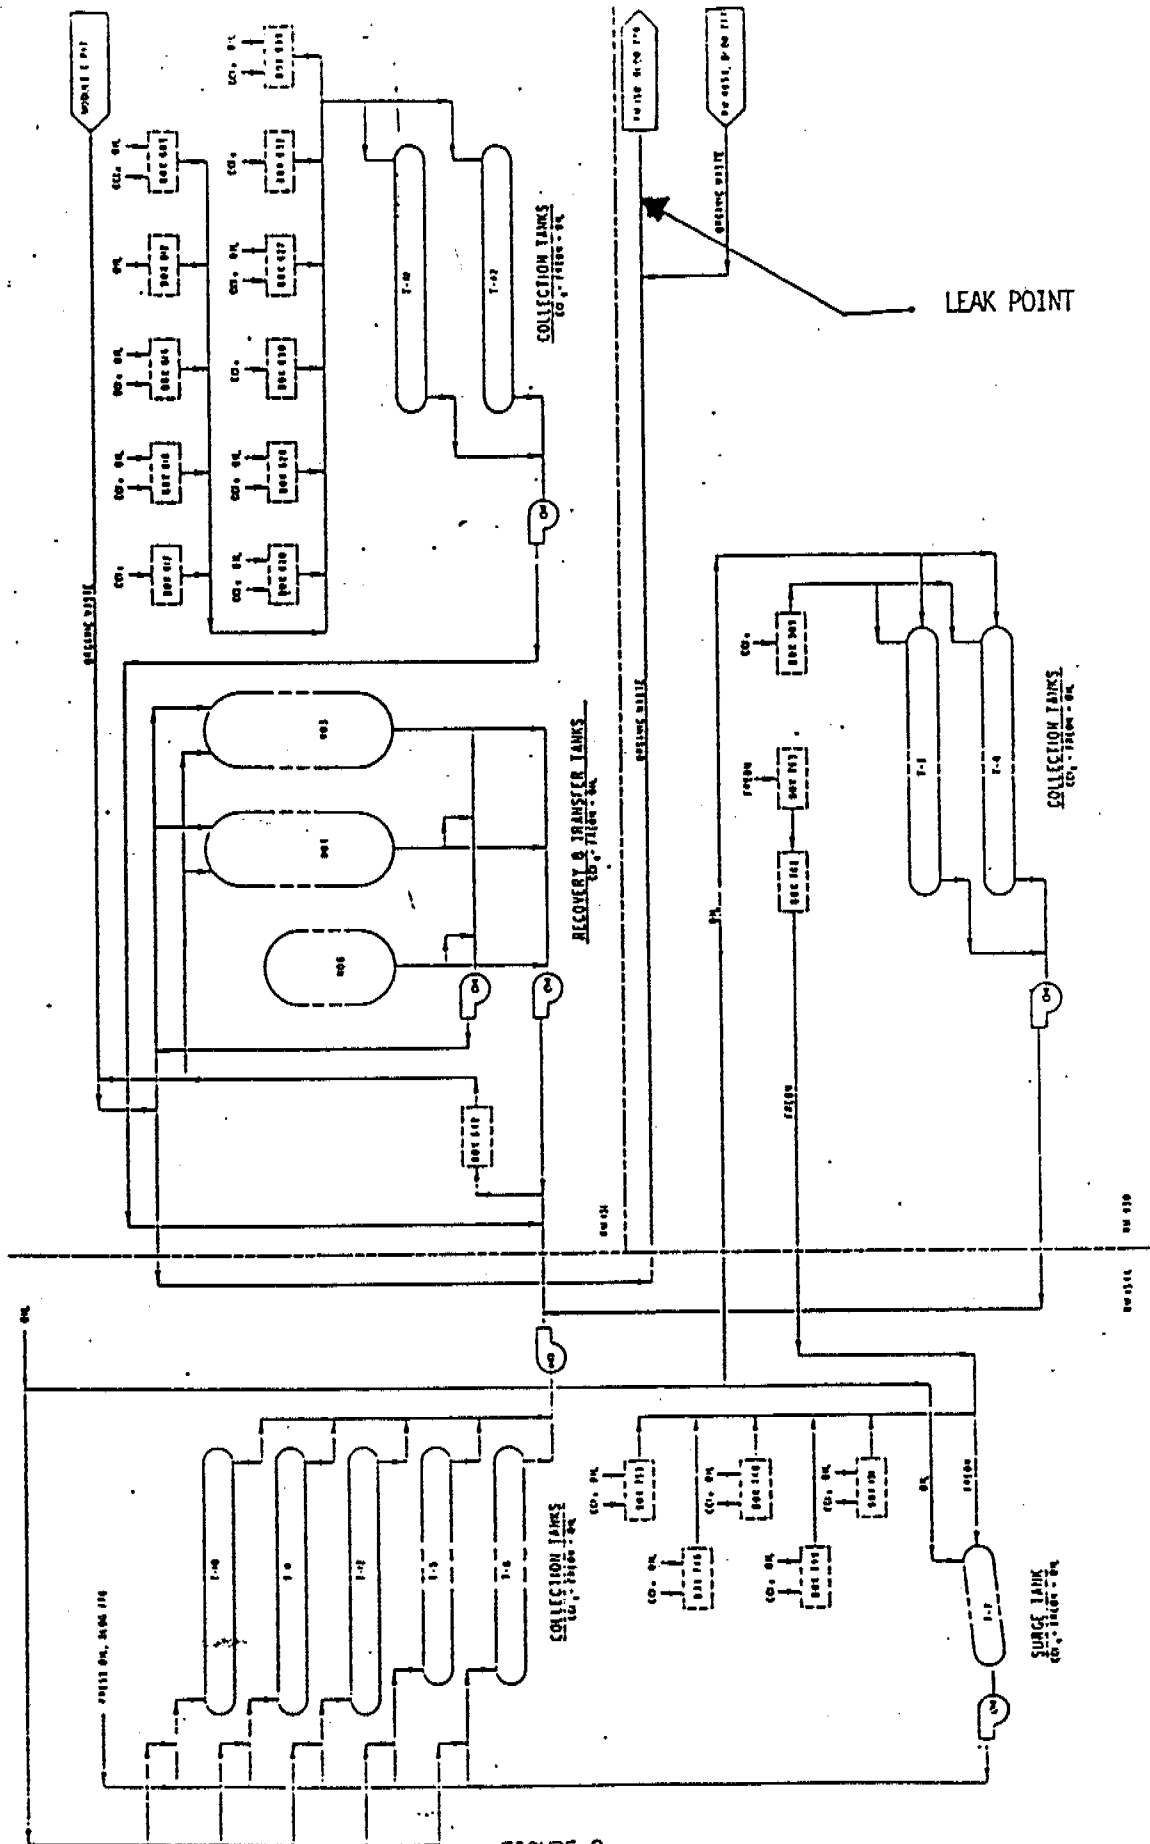
FIGURE 2  
PROCESS FLOW DIAGRAM  
WASTE MACHINE COOLANT/USED OIL TANK SYSTEM

The second leak originated from a waste machine coolant/used oil transfer line. This transfer line was used to collect liquids from the following tanks:

These tanks are used to collect waste oil solution and/or waste Carbon Tetrachloride. Each tank system collects waste solution from various machining and press operations. Each tank system is filtered and sampled through a specific glovebox prior to transfer to Building 774 for treatment. A more detailed description for each of the tank systems is included in the Building 777 Tank Systems Interim Status Closure Plan. A process flow diagram of the waste machine coolant/used oil tank system is shown in Figure 2. A schematic of the organic waste transfer lines that leaked is shown in Figure 3.

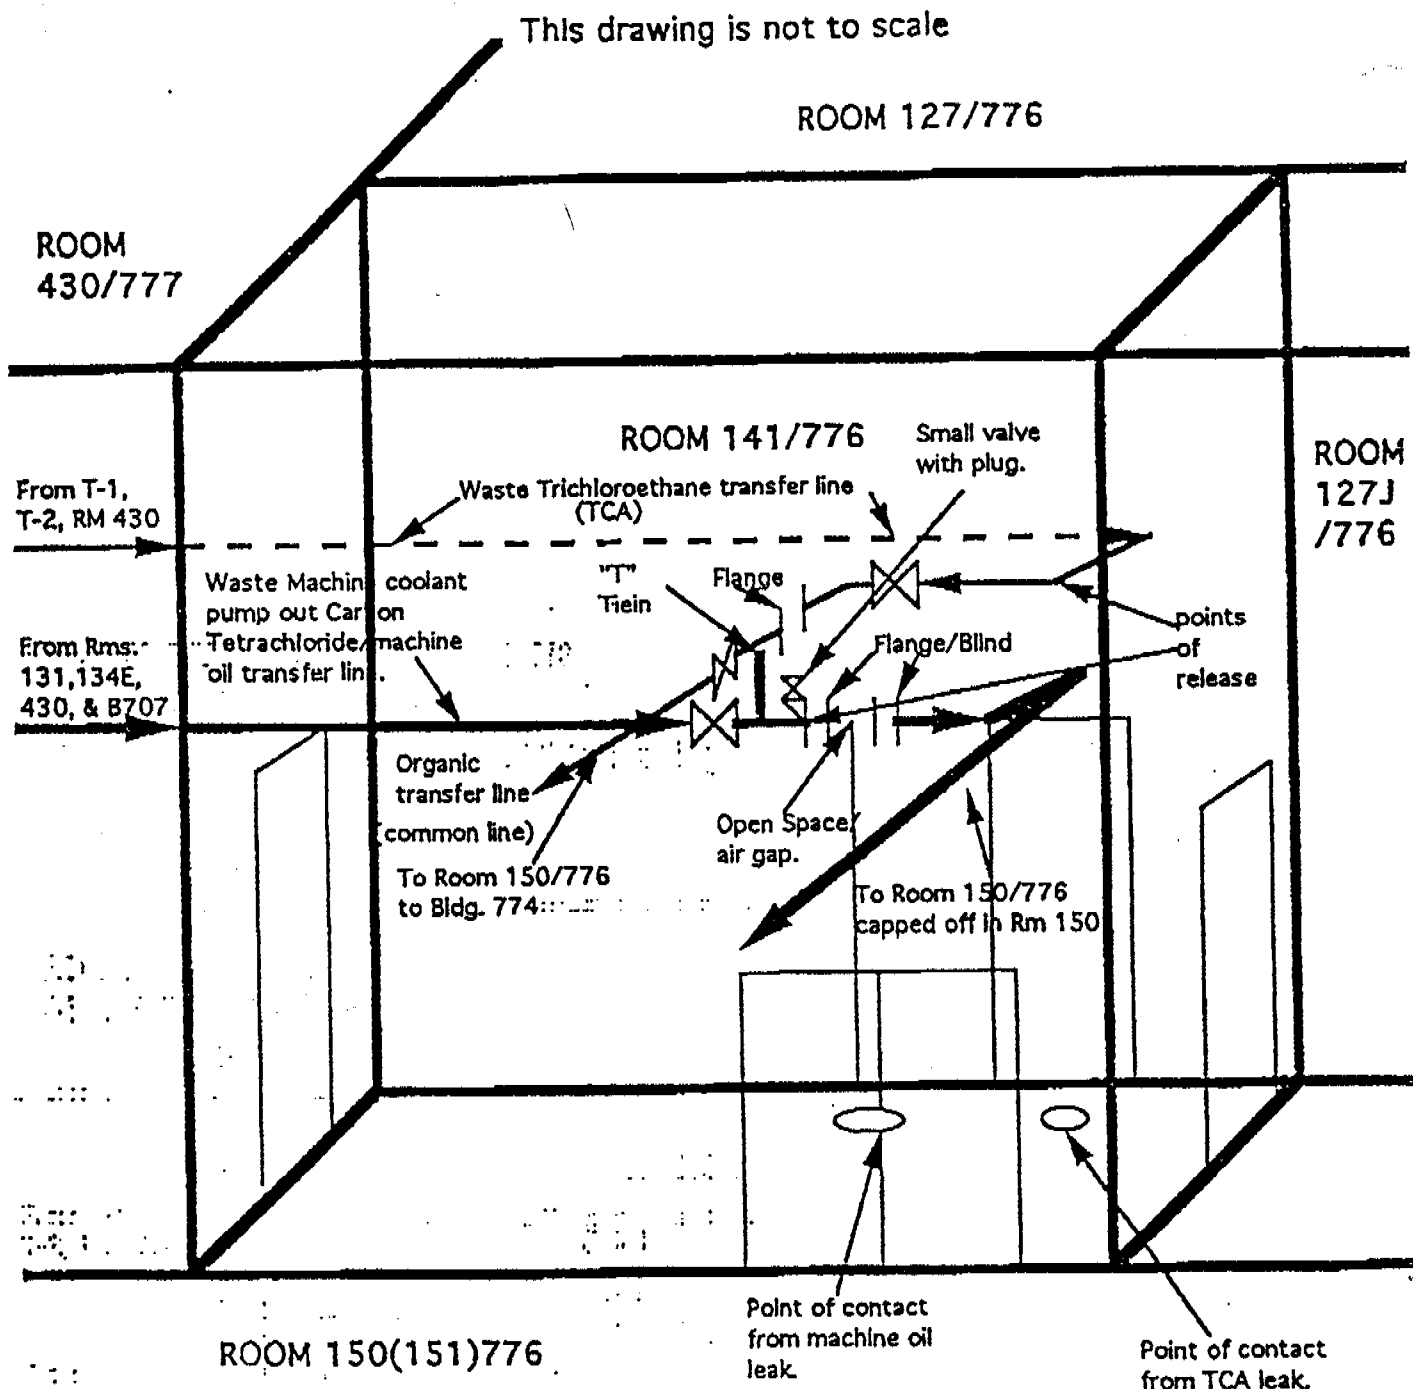
FIGURE 3  
SCHEMATIC OF LEAK POINT  
PAGE 7 OF 7

Radioactively contaminated hazardous waste leaked from two organic waste transfer lines located in the overhead of Room 141 in Building 776. The first leak occurred prior to 9:00 p.m., September 10, 1993. The second leak occurred sometime during the morning of September 13. The first leak resulted in a release of two to four drops (combined area less than two centimeters in diameter) reaching the floor. The second leak resulted in a release of one drop (less than one centimeter in diameter) reaching the floor. The following is a chronological description of the events associated with the discovery and cleanup of these leaks.

During the morning of September 13, 1993, the radioactive decontamination effort of the floor was completed. At approximately 12:30 p.m. on September 13, 1993, another drop (less than one centimeter in diameter) of radioactive contamination was observed on the floor of Room 141. Prior to leaving the room, personnel also identified a small quantity of material hanging from an elbow on the TCA waste transfer line that is located approximately 4 to 6 feet above the suspect air line. The quantity of material hanging appeared to be approximately a 1/2" long string of material. A second decontamination effort, including removal of the material hanging from the pipe, was completed at approximately 5:40 p.m. on September 13, 1993. The cause of the leak on the waste TCA transfer line appeared to be corrosion resulting in a pinhole at the weld joint on a stainless steel elbow. On September 22, during the field verification to determine the repair requirements, it was determined that the first leak originated from a waste machine coolant/oil transfer line and not from an air line. The source of the leak is a flanged connection which had

been cleaned and wrapped with plastic on September 11 to prevent the spread of further radioactive contamination.

Per the requirements of 6 CCR 1007-3, Part 265.196 (b)(1), a work package is currently being prepared to drain and repair the organic waste transfer lines in Room 141. As an interim measure, the leaking elbow and flanged connection were wrapped in plastic and taped to prevent any further release of hazardous waste or radioactive contamination. The elbow and flanged connection will be inspected daily and any visible liquid accumulation will be removed within 24 hours of discovery.
